## NEW IN THE PRODUCT RANGE: ELECTRIC CONTROLS FOR BLENDING FLAPS

- 23 electric controls in total
- For Audi, BMW, Citroen, Mercedes, Nissan, Opel, Peugeot, Renault, Saab, Seat, Skoda, Volvo and VW
- Actuators from Behr Hella Service fulfill the most stringent requirements

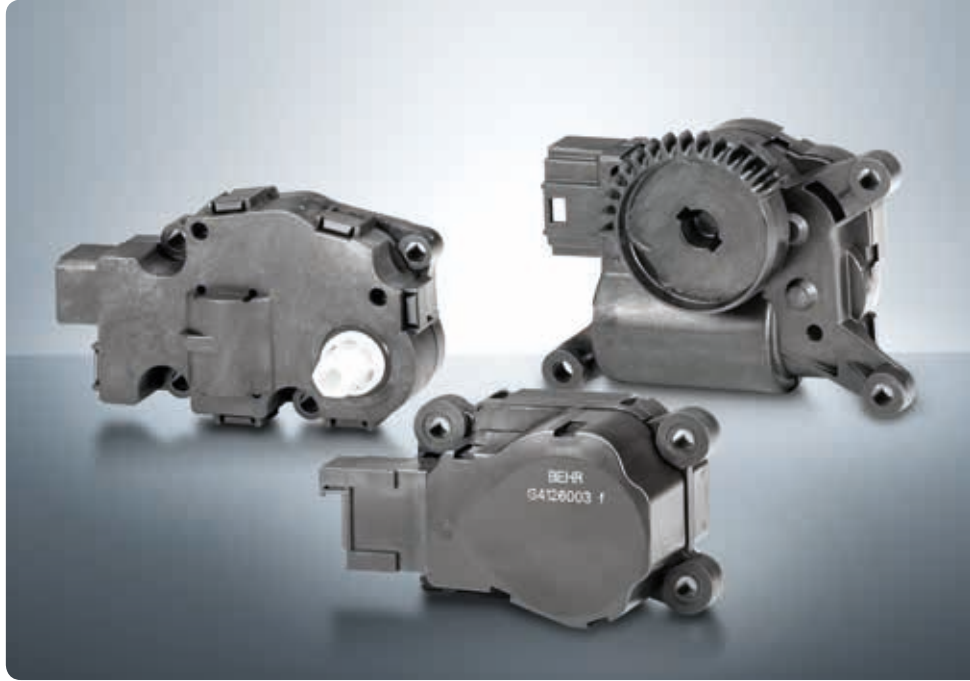
Electrically driven controls for air-conditioning systems ensure that the air flow in the vehicle cabin is distributed correctly. These actuators are mainly used in automatically regulated air-conditioning systems to control the air flaps or blending flaps so that the air flow is channeled to the correct area. A defective actuator can pose a safety hazard if a fogged or iced-over window compromises visibility. In addition to the aforementioned safety hazards, incorrect distribution of the air flows can also lower comfort levels and the concentration or awareness of the driver due to the suboptimal cabin temperature or draft, for example.
